Manhole Inspection Summary

Manhole # S09GG2015MH

Insp Date: **7/10/06 2:26 PM**

Location Address: **6202 GREEN MEADOW PKWY** Cross Street: **EDENVALE RD**

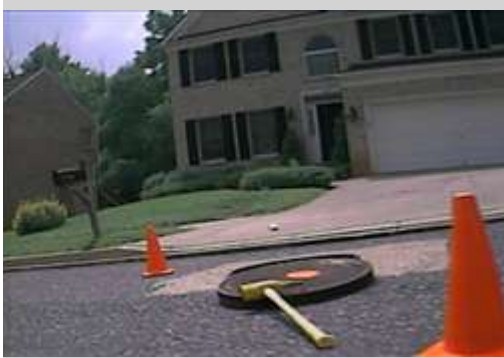
Location View

Comments **Cracks in pavement around manhole. Possible source of infiltration.**

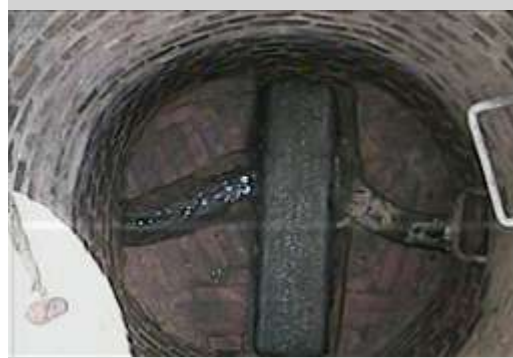
Top View

Channel Material: **Brick** ☒ Parged ☐ Debris (not Condition related)
Channel Exposure: **Fully Open** Junc Dist: **0** nearest .5 ft. Azimuth:
Condition: ☐ Sound ☒ **Cracked** ☐ Root Intrusion ☐ Deteriorated ☐ Leaks ☐ Debris

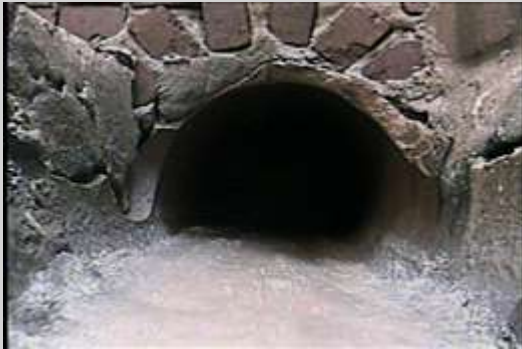
12 in. Circular Gravity Sewer Pipe Out @ 12 O'Clock

Pipe Material: **Clay** ☐ Pipe Lined

Invert Depth: **9.82** (ft.) Flow Characteristics: **Fast**

Deposits: ☒ None ☐ Mud ☐ Sludge ☐ Debris ☐ Grease

Infiltration: **None** Pipe Seal Cond: **Unknown**

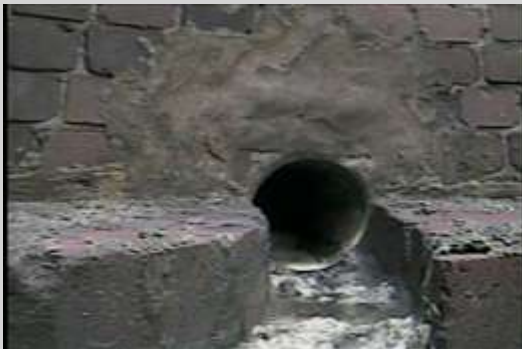
6 in. Circular Gravity Sewer Pipe In @ 3 O'Clock

Pipe Material: **PVC** ☐ Pipe Lined

Invert Depth: **9.64** (ft.) Flow Characteristics: **None**

Deposits: ☐ None ☐ Mud ☐ Sludge ☒ **Debris** ☐ Grease

Silt Depth: **0** (in.) Deposits Extent: **Light**

Connects To: **House connection / Service line**

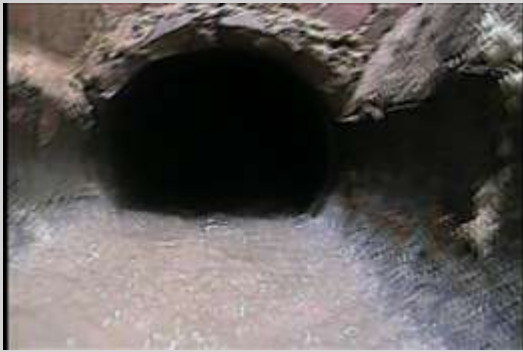
Pipe In @ 6 O'Clock

Pipe Material: **Clay** ☐ Pipe Lined

Invert Depth: **9.68** (ft.) Flow Characteristics: **Fast**

Deposits: ☒ None ☐ Mud ☐ Sludge ☐ Debris ☐ Grease

Infiltration: **None** Pipe Seal Cond: **Unknown**

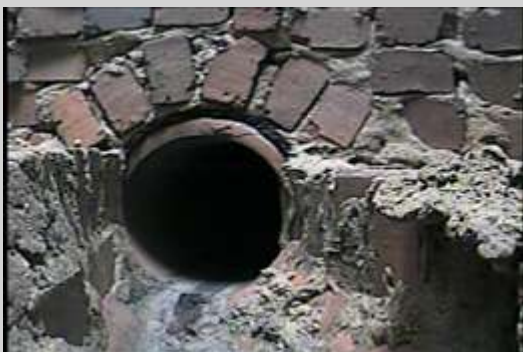
Pipe In @ 9 O'Clock

Pipe Material: **Clay** ☐ Pipe Lined

Invert Depth: **9.20** (ft.) Flow Characteristics: **Slow**

Deposits: ☒ None ☐ Mud ☐ Sludge ☐ Debris ☐ Grease

Infiltration: **None** Pipe Seal Cond: **Unknown**
